# UNDERWATER FACILITIES INSPECTIONS & ASSESSMENTS

UNDERWATER FACILITIES  
INSPECTION AND ASSESSMENT  
AT

NAVAL WEAPONS STATION  
CONCORD,  
CALIFORNIA

May, 1983

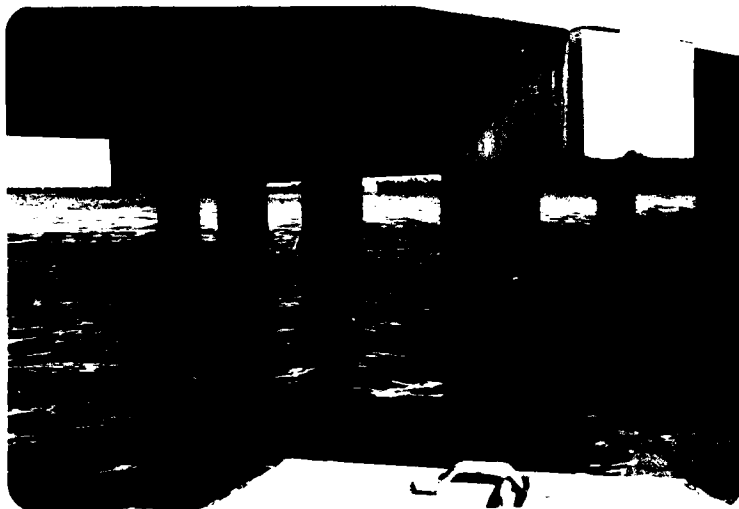
PHOTOGRAPH No. 8

Concrete Trestle. Note typical construction and excellent condition of members in splash zone.

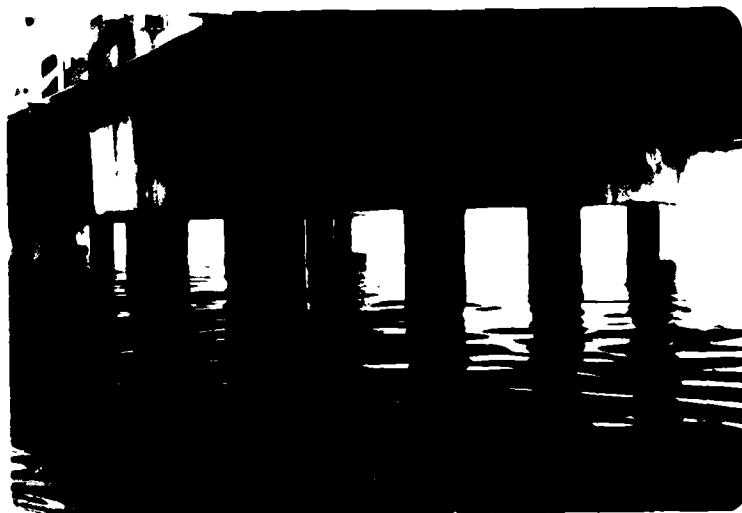
PHOTOGRAPH No. 19

Concrete Trestle - typical configuration of piles and caps. Note excellent condition of splash zones.
